VERAX Memorandum	An analysis of the effect of contact surface damage	Dnr J9807.19 Edition 1 / F59 Ratified by: Jan Webjörn 1998-07-13
---	-----------------------------------	---	---

In order to establish the risk of malfunction of a VCF-joint, because of damage to the contact surface of a flange, the following analysis is presented.

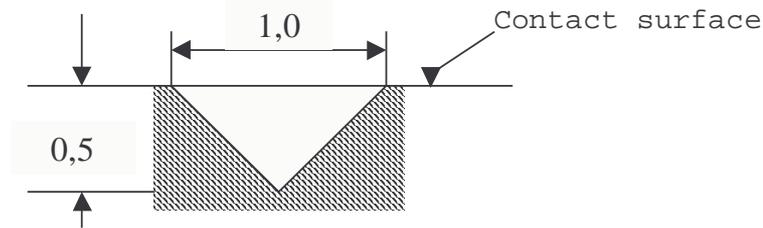
It is assumed, that a major scratch would be triangular, 0,5 mm deep, and 1,0 mm wide at its base, viz. at the flange surface. The cross-sectional area of such a scratch is 0,25 mm² and its equivalent diameter is 0,59 mm.

$$\text{Cross section area } A = \frac{0,5 * 1,0}{2} = 0,25 \text{ mm}^2$$

Equivalent diameter

$$d_e = \frac{4,0 * 0,25}{(1,0 + 2 * 0,5 * \sin 45^\circ)} = 0,59 \text{ mm}$$

If a major scratch on a contact surface of a VERAX flange has been detected at assembly, there are simple means to correct it. The simplest is to fill it with a smear of Loctite 510 or similar, of a RTV Silicone compound or such.
